# Twin Commander Aircraft LLC

## Maintenance Alert

02 September 2011

**Subject:** Corrosion of the Skin under the Dorsal Fin

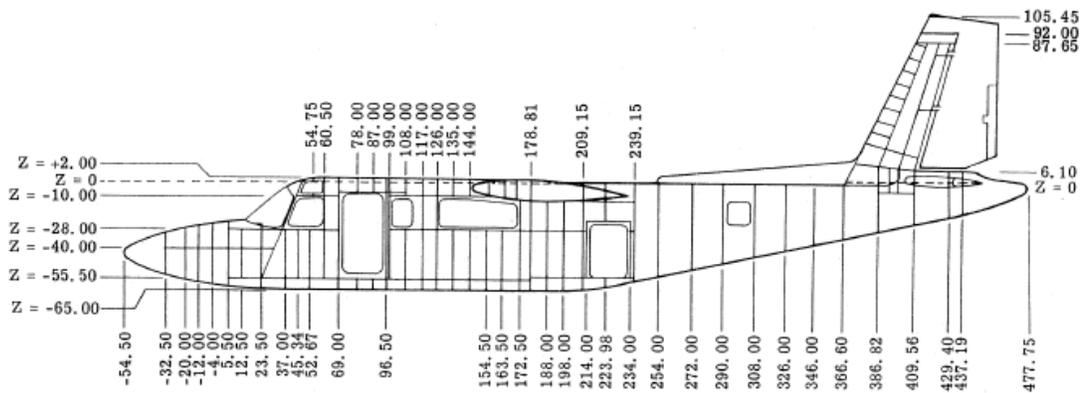
**Inspection:** The following figures show the dorsal fin styles that are potentially subject to the corrosion problem.
