# Twin Commander Aircraft LLC

## Maintenance Alert

02 September 2011

**Subject:** Corrosion of the Skin under the Dorsal Fin

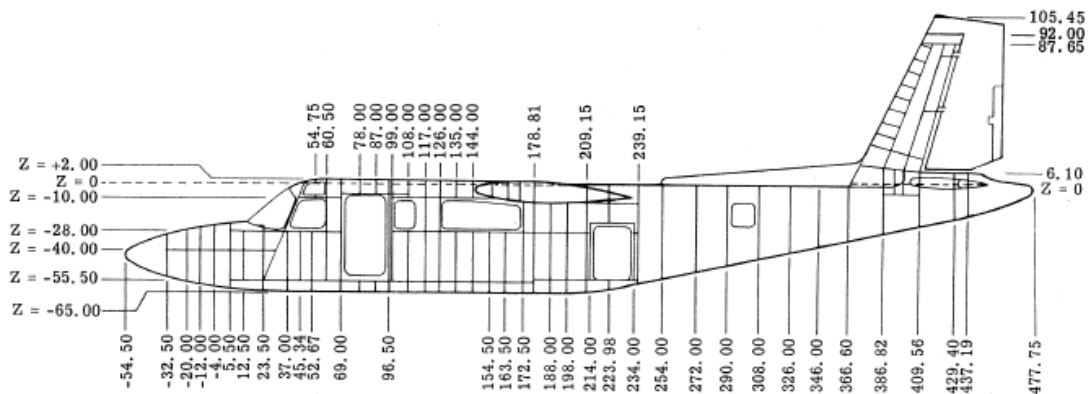
690A/B/C

**Reason:** It has come to our attention that some Aircraft with longer dorsal fins installed have been found to have excessive corrosion of the skin under the fin. The aircraft have been found with the corrosion at this location had the fin installed using a fay and or fillet seal around the periphery. This sealant application in some cases causes moisture to be trapped inside the dorsal fin, therefore causing corrosion of the aluminum skin. This maintenance alert is to ensure that aircraft at risk are checked.

**Inspection:** The following figures show the dorsal fin styles that are potentially subject to the corrosion problem.

**Action:** At the next scheduled maintenance event remove dorsal fin and inspect the fuselage skin under the dorsal fin for corrosion.

1. Remove corrosion by light hand sanding. Do not exceed the depth of defect.
2. Corrosion Convert (Alodine) reworked area.
3. Prime complete area under the dorsal with epoxy based primer per manufacturers instructions.
4. Reinstall the dorsal fin and fillet seal outside edge to aircraft skin using cabin pressure type sealant as required to conceal any gaps.

If moderate or severe skin corrosion is found, replace the skin and then follow steps 3 and 4 above. Notify Twin Commander Aircraft LLC. Please provide the total time on the aircraft. Information gathered will assist in establishing an inspection interval.
