## Twin Commander Aircraft LLC Maintenance Alert

8 March, 2016

**Subject:** Cracks in Bobweight Support Arms

**Effectivity:** Models 690D, 695A and 695B

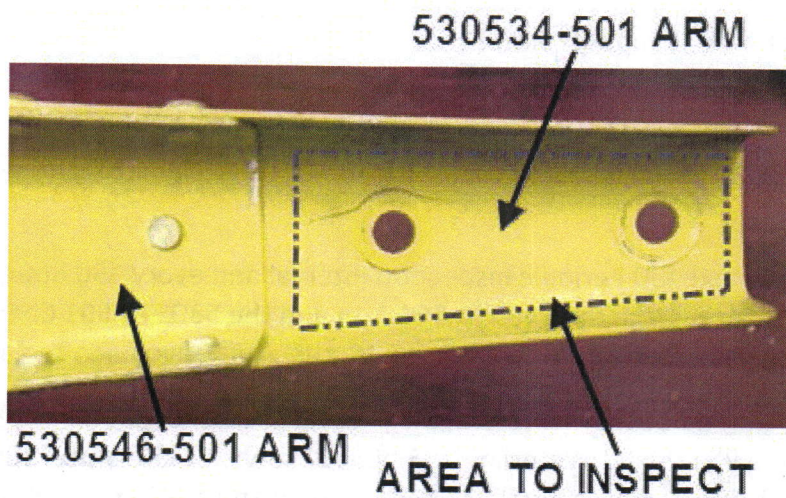
Figure 1

**Reason:** Report of cracks found in the 530534-501 Arm at the weight attachment. Refer to Figure 1.

**Compliance:** Inspect at the next 150 Periodic Inspection Interval and every 150 hours thereafter. If cracks are found replace the 530534-501 Arm and the 530546-501 Channel. This inspection shall be carried out in cases where the arms have been replaced as well.

If cracks are found, both the 530534-501 Arm and 530546-501 Channel must be replaced with the new 530534-501 Arm and 53054-503 Channel. The 530546-503 Channel has been lengthened to nest with the 530534-501 Arm for the full length providing better structural arrangement at the weight attachment point.

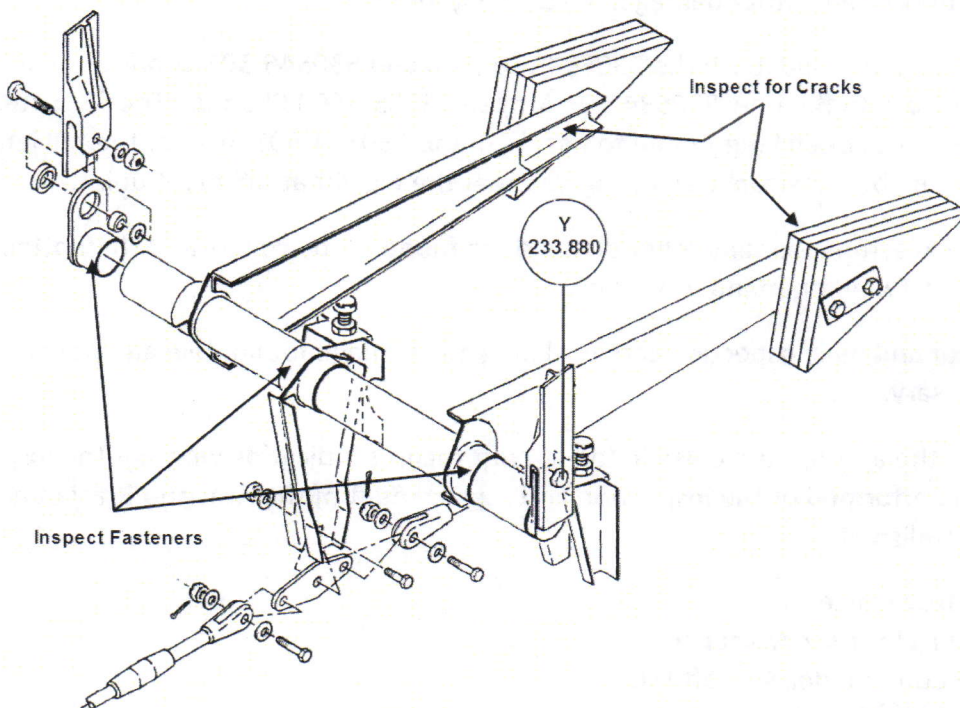
Inspect the 530534-501 Arms at the weight attachment point for cracking. Inspect 530546-501 Channel attachment to the 530535-1 Collars and 530542-1 Shaft for loose fasteners or any other damage. Refer to Figure 2

If loose fasteners or any other damage are found at the collars and shaft attach points contact Twin Commander Aircraft.
