Twin Commander Aircraft, LLC

Maintenance Alert

3 AUGUST 22

SUBJECT: Part Number 420077 Rudder Torque Tube Horn Assembly

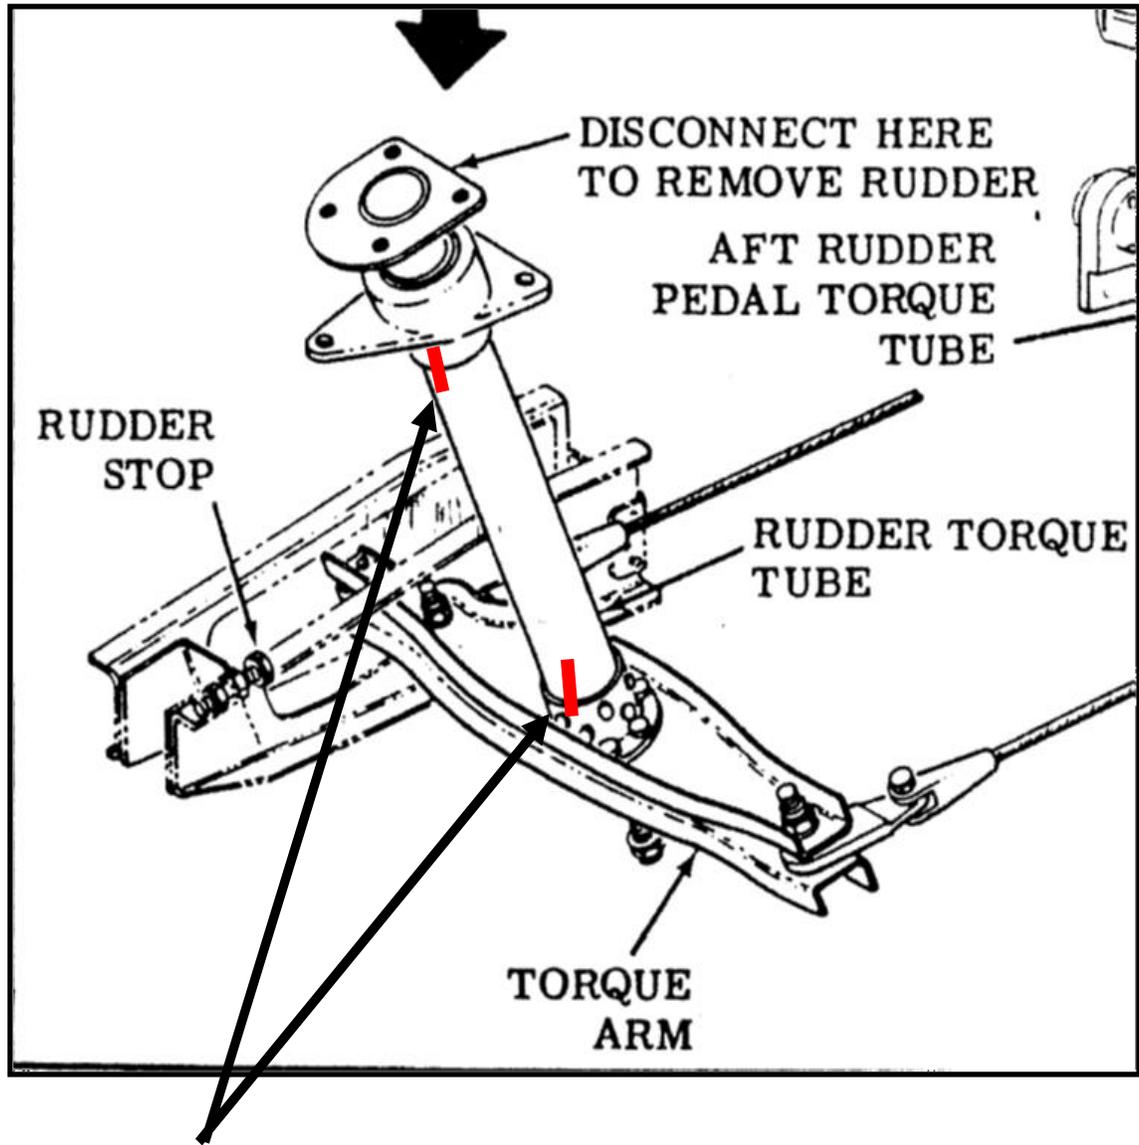
WITNESS MARK

6. Use torque seal paste or equivalent to mark across either end of the tube and fittings so that future movement of tube, should it occur, can be more easily detected (see figure below).
